STRUCTURAL ENGINEERS REPORT

Subject Cropwell Bishop Memorial Hall
Nottingham Road
Cropwell Bishop
Nottingham
NG12 3BA

Our Ref. P20055

Inspection Date 26 August 2020

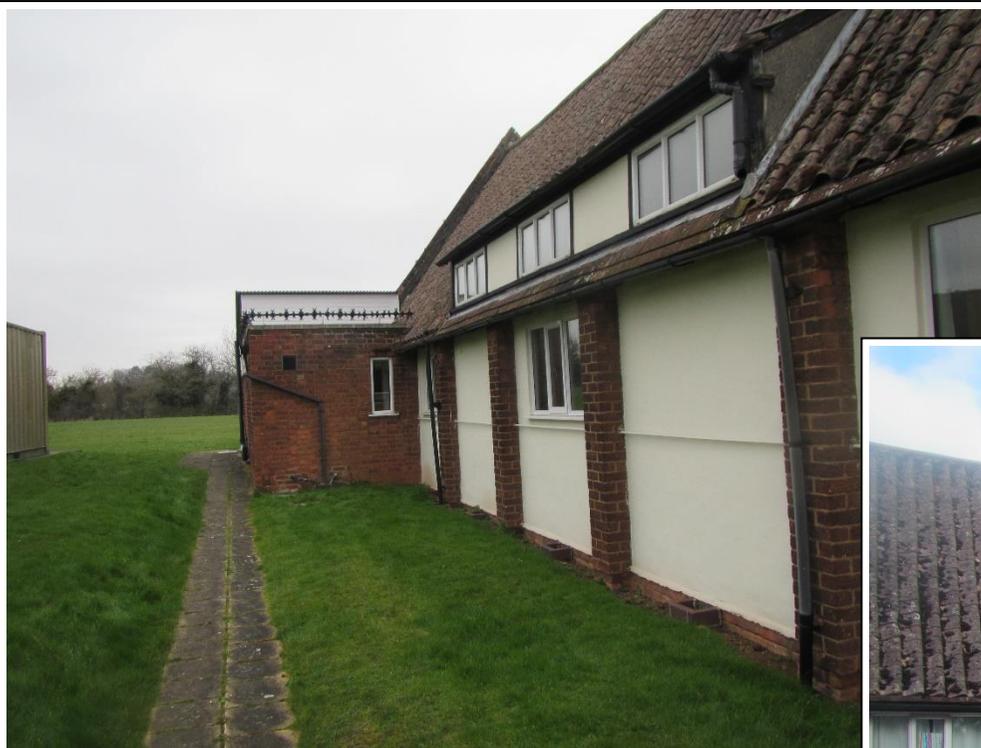
- 3.4 The left-hand side wall to the main hall is constructed generally with rendered 4½" thick masonry with external piers (not rendered). There is an external tie bar. The masonry piers and the infill panels lean outwards. There is fine cracking to the rendered panels.

- 3.5 At the side of two of the piers there is vertical cracking up to approximately 6mm wide. There has been lateral movement at the base of all of the piers, in some areas the movement is towards both the front and the left-hand side. At these positions, the upper brickwork projects over the lower brickwork by approximately 18 mm (although slightly higher in some areas).

1.- Left-hand side wall

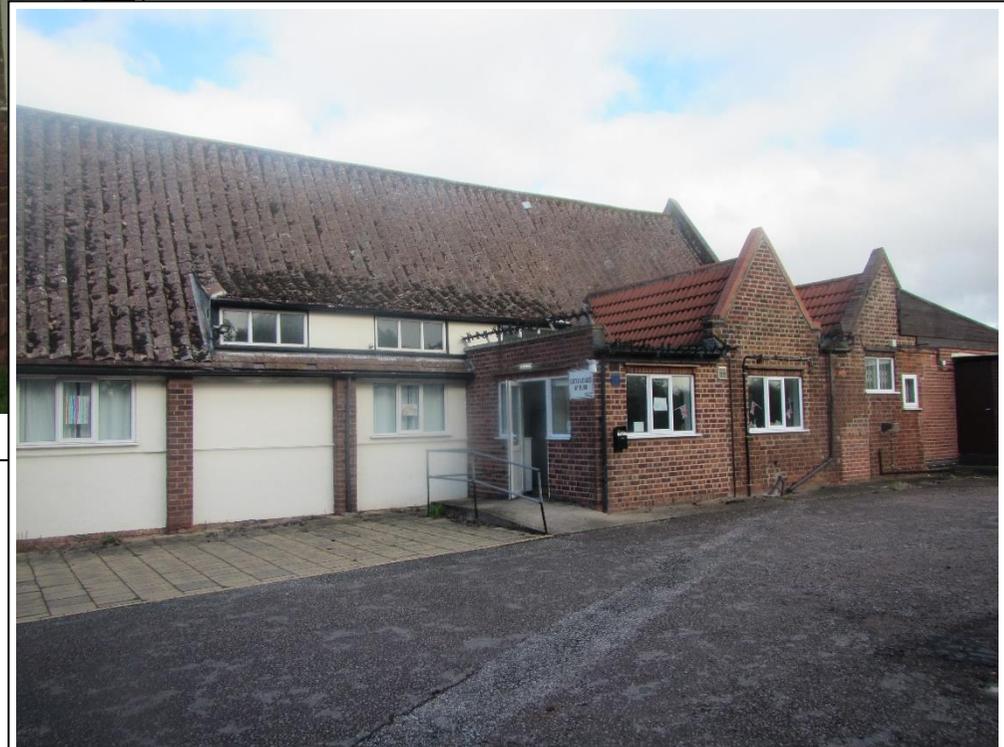
- 3.8 The main hall right-hand side wall is constructed the same as the left-hand side wall, again there is a tie bar visible. Both the masonry piers and the infill rendered panels lean outwards and again there has been lateral movement at the bottom of the piers. There is flaunching at the junction of the roof with the front gable, the cracking to this is more pronounced at a low level. There is distortion/bowing to the upstanding gable brickwork/parapet. There are uneven asbestos tiles and broken asbestos to the dormer end.

2.- Right-hand side wall

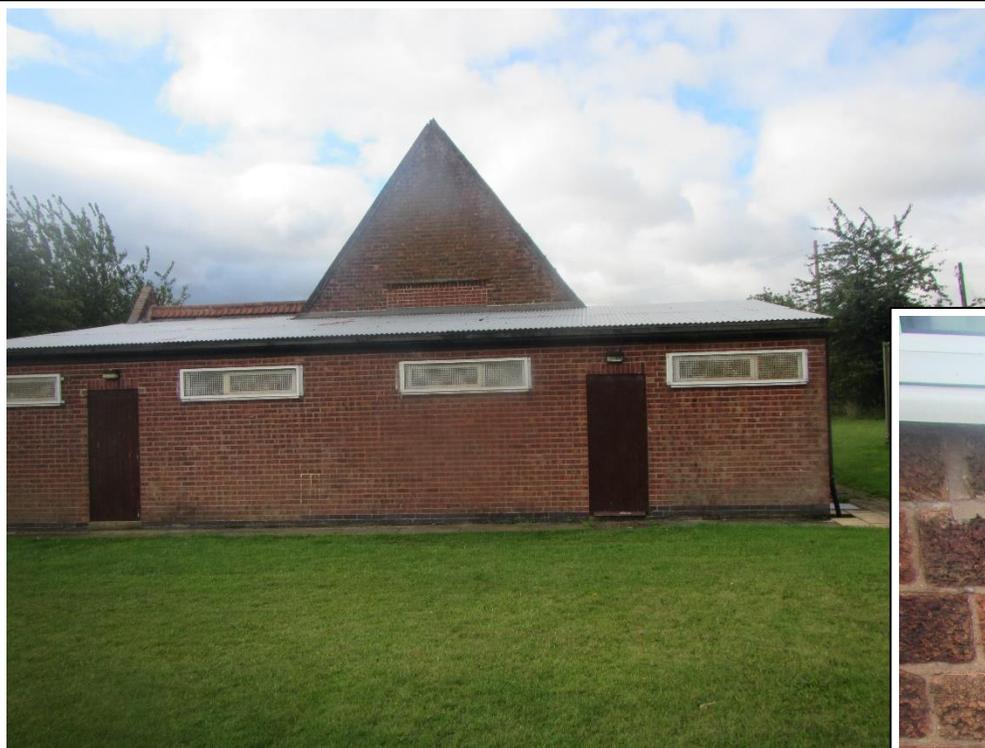
- 3.3 The main hall rear elevation gable can only be viewed from distance, this has a visible lean outwards near to the ridge. There is also bowing visible near to ridge level on the left-hand side. To the full width rear projection there is fine cracking above one door. To the lean-to right-hand store there is considerable brickwork decay at a high level.

3.- Rear elevation

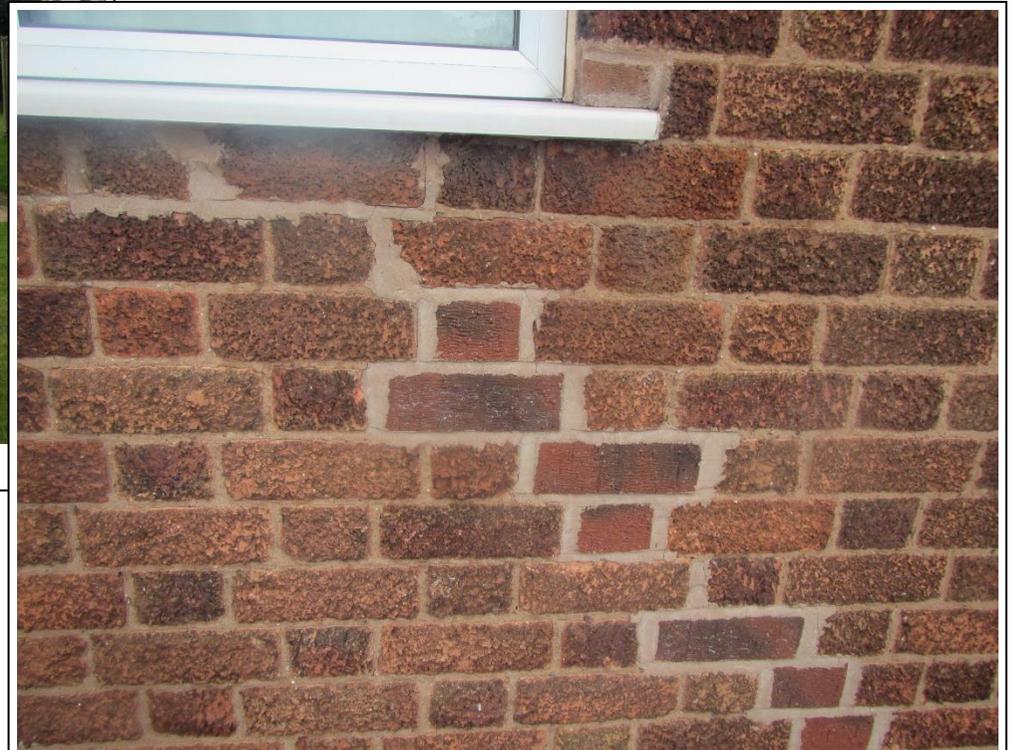
3.1 Externally, to the main hall front elevation there are endplates to tie bars present on the left and right-hand corners. The wall leans outwards by up to approximately 1 in 43. The wall bows outwards at approximately

eaves level and at ridge level leans inwards very slightly. There is a raking crack repair beneath the left-hand window. There has been slight lateral movement at damp proof course level on the right-hand side.

4.- Past repairs to front gable

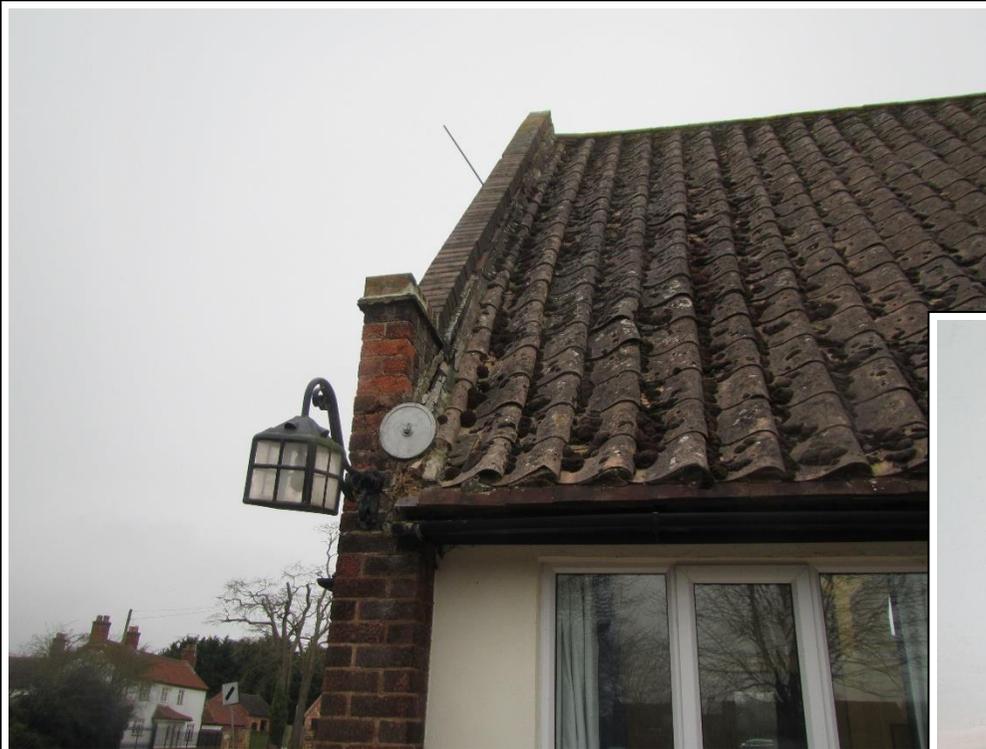
- 3.6 At the junction of the main hall left hand elevation roof slope with the front gable there is a wide band of flaunching which has shrinkage cracking. There are uneven asbestos tiles.

noted to one raking member (supported on the front gable) there is water staining to the purlins spanning onto both the front and the rear gables. Externally there has been past repairs with flaunching adopted between the asbestos tiles and the masonry gable. There are varying degrees of cracking, which could let water in.

5.- Mortar flaunching at the junction of the roof with the front gable

- 5.6 The external flaunching at the junction of the roof covering with the gables should be repaired and maintained in the future, to prevent water ingress. The decayed raking timber member attached to the gable below ceiling level should be fully exposed and either repaired or replaced, dependent on the amount of decay present once it has been exposed. Where the existing purlins are built into the walls, they should be locally exposed by a builder to ensure that they have not decayed where they are embedded and that there is still a reasonable bearing length. This is particularly relevant for the front gable where it has moved out pronouncedly.

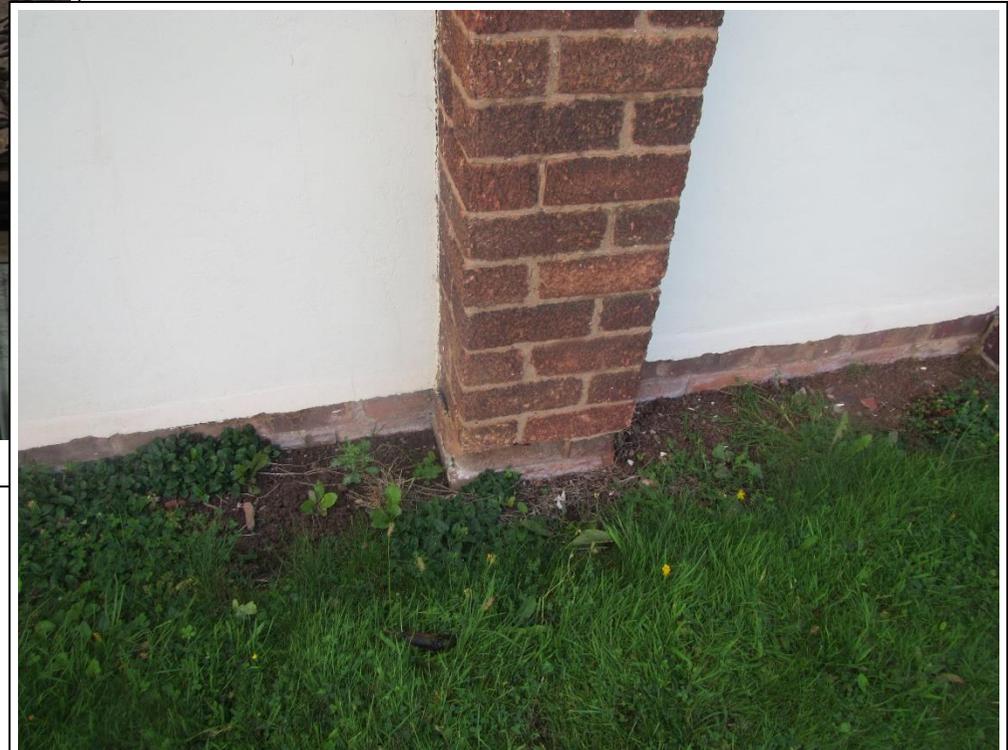
6.- Typical movement at the bottom of the main hall external piers

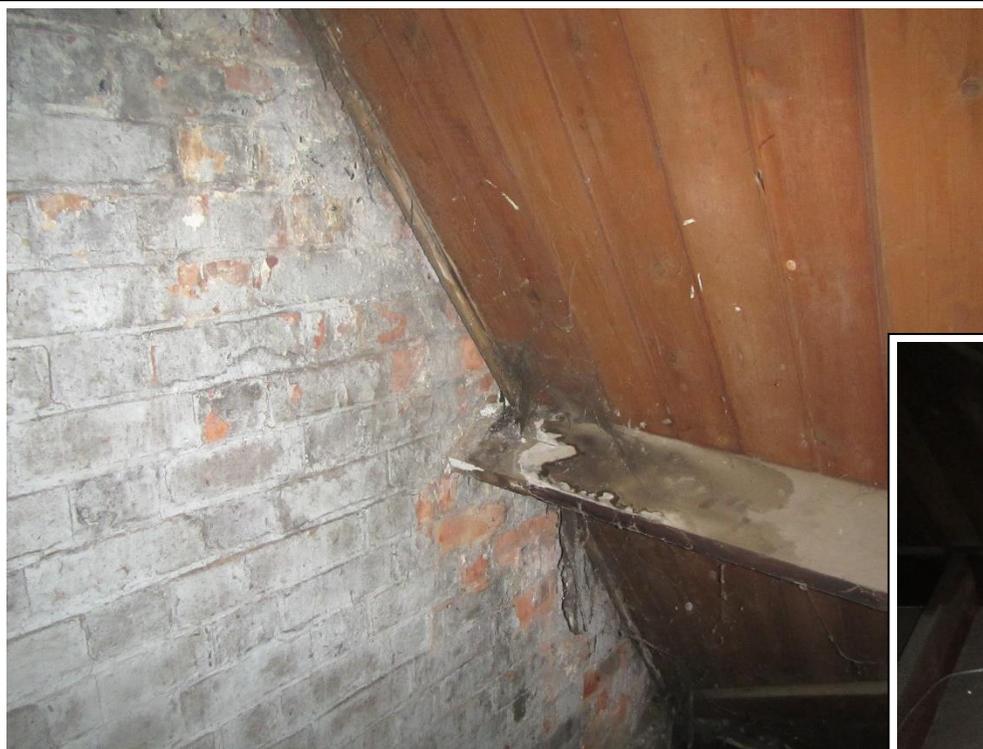
- 3.11 The roof void to the main hall was accessed. The original roof slopes are tongue and groove boarded/underdrawn. There are two purlins to each slope above the more recent ceiling level. Internally at the junction of the lower left-hand purlin with the main gable there has been approximately 60mm of movement, with the gable moving outwards leaving a gap between the boarding and the gable. There is slightly lesser movement in other areas. There is water staining visible to the purlins, however, at the time of our visit they were dry and there was no evidence of any timber decay to the exposed sections. The newer ceiling joists span left to right and appear to be supported at their ends by original timber members/purlins spanning front to rear, supported by the gables and the internal timber roof trusses.

7.- Front gable – Water staining at the purlin ends

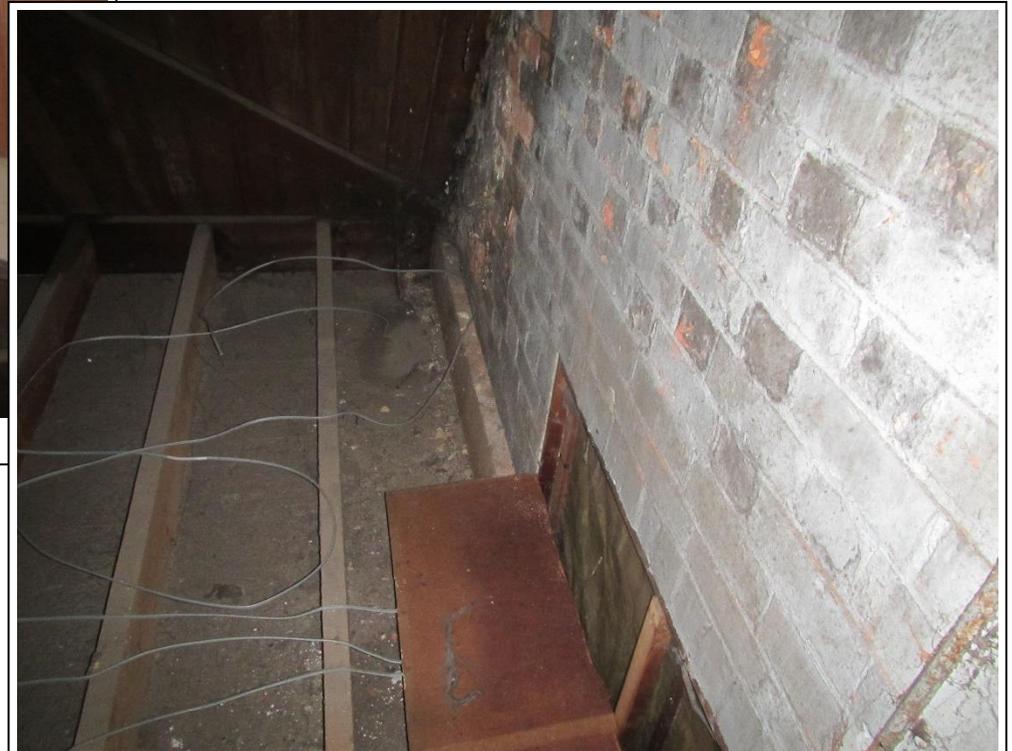
8.- Front gable (internal)

- 3.10 Internally in the main hall there has been decay at the junction of a roof raking member with the front gable. The internal support posts to the main hall roof on the left-hand side have slight leans towards the left-hand side wall and on the right-hand side slight leans towards the right-hand side wall. Several also have a slight lean towards the front. The external wall leans are mirrored internally, there are further tie bars present to the side walls.
